# FIN FAN VIBRATION REMEDIATION

Richard M. BALDWIN<sup>1</sup>, P. Joe PANTERMUEHL<sup>1</sup>, Venkat K. PILLAI<sup>2</sup>

## SUMMARY

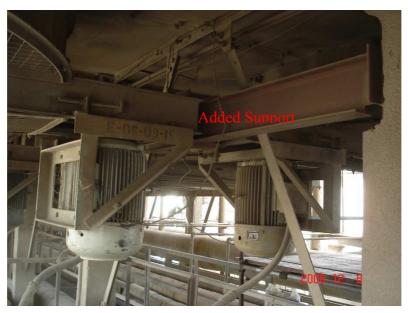
Included in the list of fans tested were selected ones which had prior modifications installed, that sought to reduce the vibrations such as the one shown in Figure 1. Two of these were fans which had experienced failures, and one "good" fan.

Figure 1. Motor End of Fan with Vertical Support Added Previously.

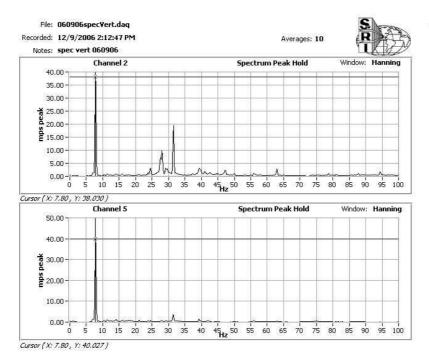
• There is insufficient support stiffness in the structure to resist any more than minimal vibratory energy. The entire fan skid is suspended from the ceiling (plenum), which is flexible and has only small vertical supports. Figure 2 shows that the ceiling plenum vibrates at about the same amplitude as the motor mount in the vertical direction. In the absence of stiffness in the plenum, support can be applied directly to the fan and motor skid. Prior vertical supports installed on the fan end of certain machines appear to address this need for greater vertical stiffness. The temporary modification tested also accomplished this vertical support objective, using somewhat less material.

Figure 2. Comparison of Fan Skid (bottom – 40 mm/sec, 0-p) and Ceiling Plenum (Top – 38 mm/sec, 0-p) Vibration at Fan Speed (7.8 Hz.), Unbraced

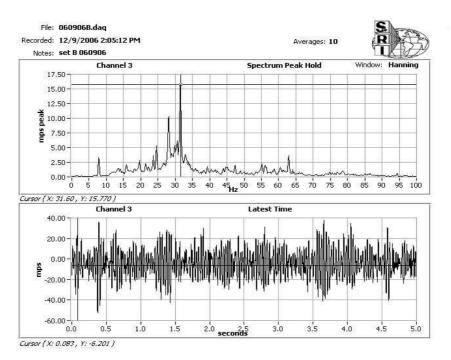
- The channel beams that constitute the main structure of the fan skid are too flexible to resist the normal rotating forces placed at the center of the skid by the fan. The vibration is usually larger in the horizontal direction than the vertical direction, but both modes are significant in some fans. This vibration occurs at or near blade-pass frequency and, therefore, is not driven by rotating unbalance of the fan (see Figure 3). It can be influenced by blade asymmetries. Diagonal braces installed previously on a few fans appear to be intended to resist the horizontal component of this motion. The wooden beams installed between adjacent units during the current sensitivity testing also reduced the horizontal component of the vibration. Compare Figure 3 with Figure 4.

Figure 3. Horizontal Vibration at the Fan with NO Horizontal Bracing. Note Blade-Pass Frequency (31.6 Hz) is 15.7 mm/sec, 0-p.

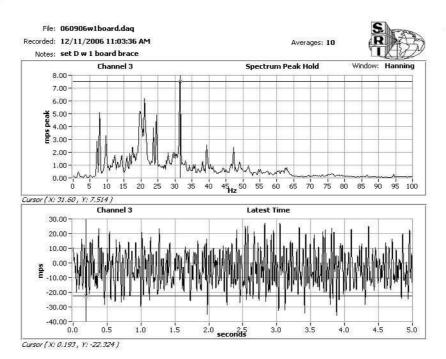
Figure 4. Horizontal Vibration at the Fan WITH Horizontal Wooden Bracing. Note Blade-Pass Frequency (31.6 Hz.) is Reduced by Half to 7.5 mm/sec, 0-p.

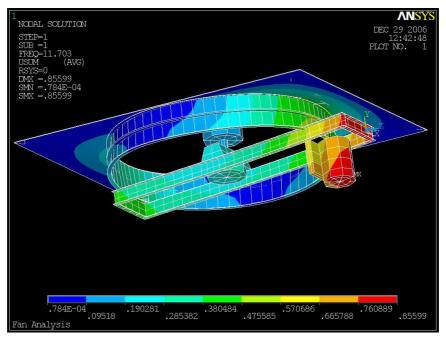
- A vertical bounce mode of the fan skid with the leading motion at the motor end. This motion takes place at the fan speed of 7 to 7.8 Hertz (Hz). The resonance of this mode is about 10-12 Hz.
- A lateral vibration of the fan skid at its center location where the mass of the fan and its support structure are attached to the skid channel beams. This motion is predominately at blade-pass frequency of 27 to 32 Hz, while its resonance is 12-13 Hz.
- A mode of vibration of the motor and its mounting frame controlled by the stiffness of the bolts that attach it to the fan skid and by the motor mass. This mode occurs at or near motor speed of 24.4 Hz.

Figure 5. Modal Analysis of Motor Vertical Vibration Mode at 11.7 Hz.

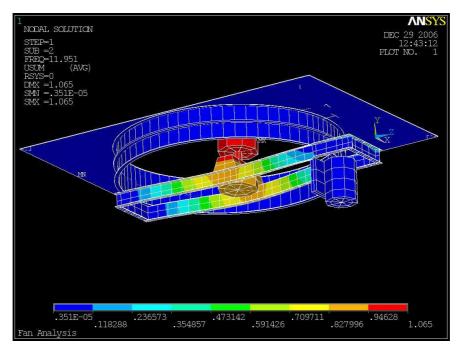
Figure 6. Modal Analysis of Horizontal Skid Vibration Mode at 12 Hz.

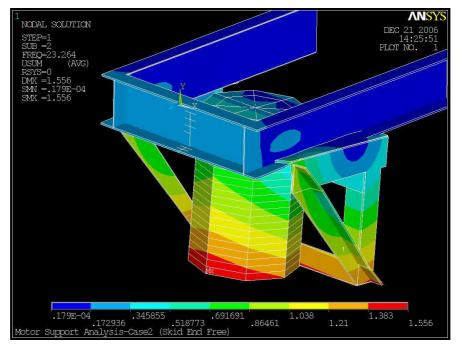
Figure 7. Modal Analysis of Motor Bracket Results (Skid End Free). Resonance at 23.3 Hz.

The FE model was used to identify the motor bracket mode of vibration, as shown in Figure 7. The model shows that the expected resonance, for the large motor, is 23.3 Hz (just below motor excitation frequency of 24.4 Hz) and the motion is a rocking of the motor mount relative to the skid side channels. The model then applied the vertical stiffness caused by the supports added by modifications. This moved the mounting resonance up to 24 Hz, which coincides with motor running speed, thus amplifying that mode of vibration, while the vertical bounce mode is greatly reduced (see Figure 11). This is what was witnessed during the testing.

The model was then used to add a 12 mm thickening plate to the top of the angle bracket that attaches the motor mount to the channel skids. As a result, the model predicts a shift in the resonance up to 56.7 Hz, well away from motor speed.

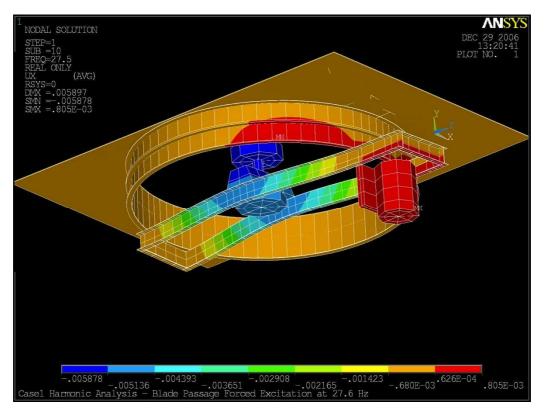
For the horizontal vibration mode of Figure 8, the finite element (FE) model was used to determine the force required to produce the (largest) measured response of 10 mils (23mm/s) at 27 Hz at the fan location in the horizontal direction. This force (137 lbs) was then applied to the model and modifications were identified which could control the vibration.

Figure 8. Harmonic Analysis Forced Excitation at 27.5 Hz (137 Lb 0-peak). Horizontal Vibration Amplitude Approximately 0.91 ips 0-pk (23 mm/s 0-pk) at 27.5 Hz (30 HP Motor, Fixed Pitch Hub).

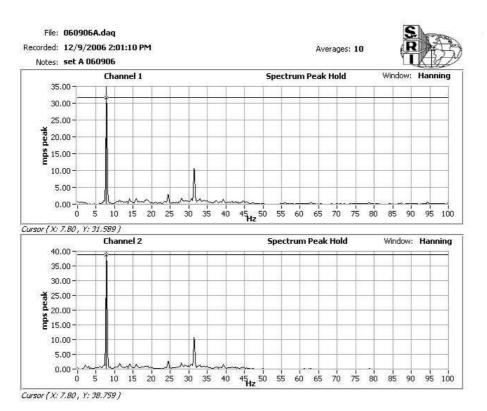
Figure 9. Vertical (top) and Horizontal (bottom) Vibration of the Motor and Mount of Fan E-06-09-M6 without Vertical Support Modification. Note Fan Speed Vibration at 7.8 Hz.

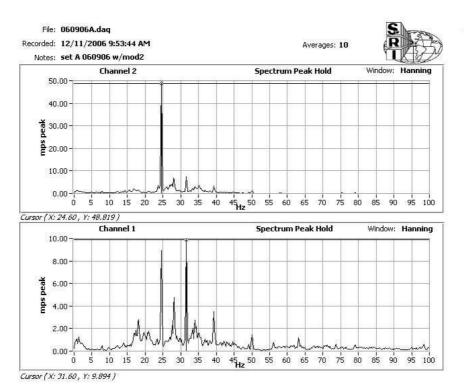
The trial modifications tested in the field treated the first (bounce) and second (fan and channel lateral vibration) of these modes. The resulting increased stiffness allowed the third mode to be uniquely identified, as it was the remaining vibration mode, which apparently had become resonant as a result of the vertical stiffening of the skid. Figure 9 shows the motor frame vibration without vertical supports. The main motion is at fan speed 7.8 Hz. After vertical bracing, Figure 10 shows that the 7.8 Hz motion is removed, the system is stiffened, and the motor mounting mode is excited at 24.6 Hz.

Figure 10. Vertical (bottom) and Horizontal (top) Vibration of the Motor and Mount of Fan E-06-09-M6 with Vertical Support Modification. Note Fan Speed Vibration at 7.8 Hz Removed and Motor Speed (24.4 Hz) Amplified.

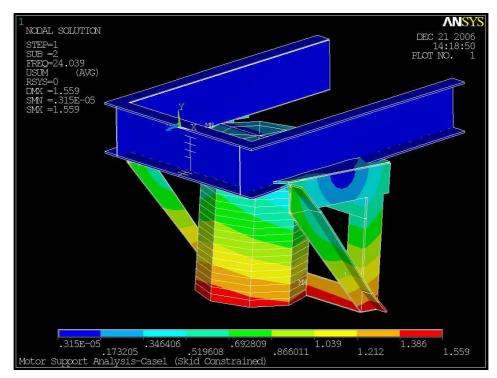
Figure 11. Modal Analysis of Motor Bracket (Skid End Fixed, 30 HP Motor) (Bracket Tied to Skid Channel at Two Bolt Locations Each Side) Results in 24 Hz Resonance- Motion In Line with Long Axis of Skid.

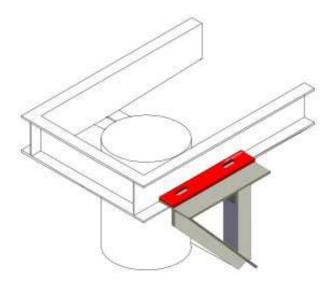
Figure 15. Illustration of 12 mm Thickening Plate for Attachment of Motor Mount to Fan Skid.

3. The motor mount mode of vibration identified at or near motor running speed (24.4 Hz) was restrained by stiffening the motor mount and its attachment to the fan skid. Figure 15 shows the stiffening plate for control of this mode of vibration. The frequency of this mode was increased from near 24 Hz to 57.2 Hz by combining the effects of both the vertical support and the motor mount modification.
