FAILURE ANALYSIS OF IMPELLER BLADE CRACKING IN A MECHANICAL VAPOUR RECOMPRESSOR (MVR) FAN

Brian DONOHUE, Milo KRAL

Department of Mechanical Engineering, University of Canterbury, New Zealand

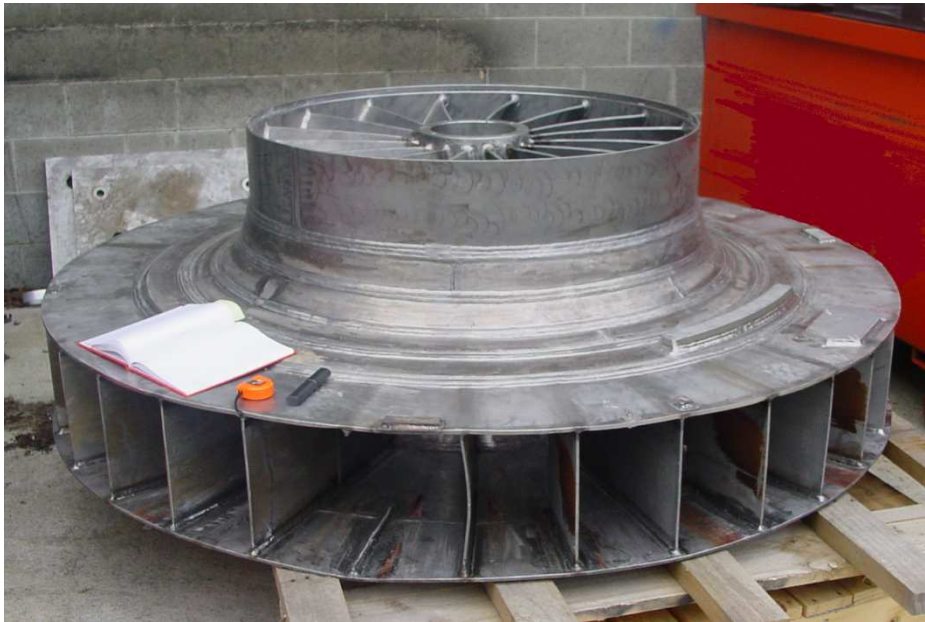
Three milk powder production facilities were recently commissioned in New Zealand, the plants are essentially identical. One plant processes fifty percent more milk volume than the others but all have the same potential total capacity. The production system involves an evaporation process to remove water from milk to produce powder. The fan used to circulate powder through the drier is a mechanical vapour recompression fan, shortened to MVR. Shortly after commissioning of the higher production factory, the MVR fan suffered a catastrophic loss of a blade. Travelling at 730km/h, the blade travelled up the discharge duct and into the evaporator destroying many tubes along the way. The plant was only 150 hours old. Needless to say there was a high level of concern, not only on safety grounds, but because of the risk of failure in the other plants and there were also several similar fans installed in plants around the world. A brief examination of the fracture surfaces of the broken blade revealed that fatigue had occurred close to both welded edges where it connected with the front-ring and backplate of the impeller. Scanning electron microscopy confirmed that this was the case. Figure 1 shows the impeller and the area where the blade was ejected.

Figure 1 Photograph of the MVR impeller with missing blade

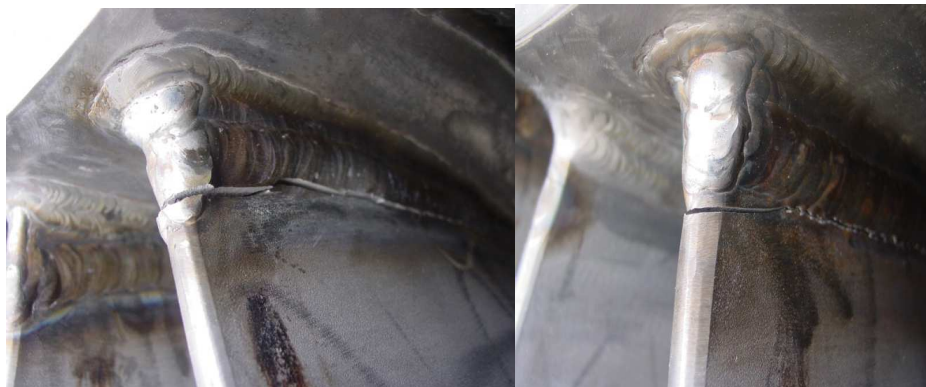
At the outset the study concentrated on material failure, as the first thoughts were of possible weld defects, laps, heat affected zone, residual stress, and other issues associated with weldments. Visual inspection had shown a possible lack of fusion as the failed blade had simply pulled out of the weld with little adherence evident. Dye penetrant testing revealed crack indications on almost every blade weld. The presence of residual tensile stresses was indicated by yawning cracks at blade edges, see Figure 3. A cracked blade was cut away from the impeller and the crack opened up for examination. Beach marks were visual indications of fatigue and numerous initiation sites could be seen on either side of the blade. Scanning electron microscopy revealed the presence of fatigue striations which was clear evidence that fatigue was the cracking mechanism; see Figure 4 (from [1]).

Figure 3: Photographs showing typical cracks evident at several short blade location, showing residual tensile stress

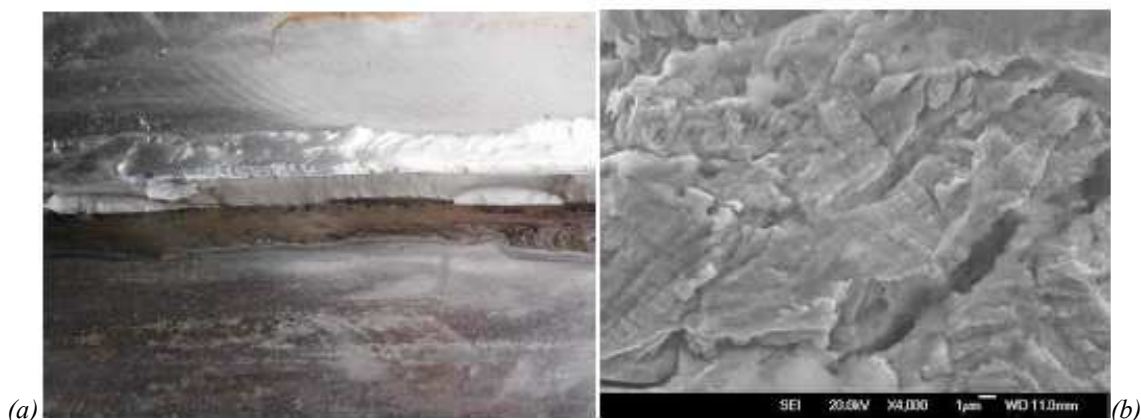
Figure 4 (a) Opened cracks showed the classic visual appearance of fatigue with many initiation sites on either side of the blade as indicated by arrows and (b) Scanning electron microscopy showed fatigue striations on the thrown mid-blade fracture surface.

At this point in the analysis, it was only clear that fatigue was the fracture mechanism and that there was a lack of fusion in the thrown blade. However, other fan blades were cracked as well. One possible explanation for the impeller failure was that the blade with a defective weld had fatigued due to resonance then severe vibrations occurred due to imbalance after the blade was thrown, which in turn resulted in other cracks being formed. So, a root cause analysis [2] was carried out since a source of stress to drive fatigue crack growth in the thrown blade had not been immediately identified. In seeking a source of stress, two vibration modes were conceptually identified: a blade ‘flapping’ mode and a torsional mode - see Figure 5.

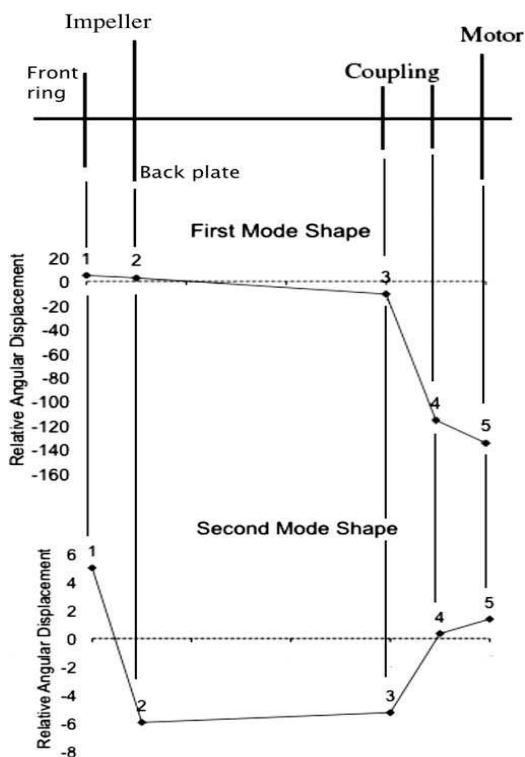
Figure 8: Mode shapes for vibration in torsion

The mode shapes (Figure 8) obtained from the analysis showed that for the first mode the nodal point is situated approximately at the in-board fan bearing. In the second mode there are nodal points between the impeller backplate and front ring and at the coupling, showing that the second mode vibration has reversed torsional loading at the impeller and coupling. The mode shapes did not vary much when adjusting the coupling stiffness in the analysis to allow for non-linearity. However, the first modal frequency increased from 8 Hz to 33 Hz. The analysis showed that the first mode was always within the speed range of operation, 300 rpm (5 Hz) to 2150 rpm (35.83 Hz), where at 72 Hz the second mode was outside the operating speed range. FEA studies confirmed that there was a variable frequency first torsion mode due to non-linear coupling stiffness and that the second mode frequency remained unchanged. The FEA study was based on the solid model shown in Figure 7. The model was a simplified version of the actual impeller, where the blade form is not exact as details were not available to enable proper modeling.

For each torsional mode, node crossings (amplitude equal to zero – see Figure 8) usually indicate areas with highest stress while antinodes (high amplitude) indicate maximum angular oscillation. Based on the calculated mode shapes shown in Figure 8, the first torsional natural frequency would be responsible for causing fatigue cracks in the shaft keyways near the coupling hubs and damaging the coupling rubber elements. The 2nd mode is the one most likely to cause a large oscillatory motion between the impeller front and back plates. The damaging effect of 2nd mode oscillations is

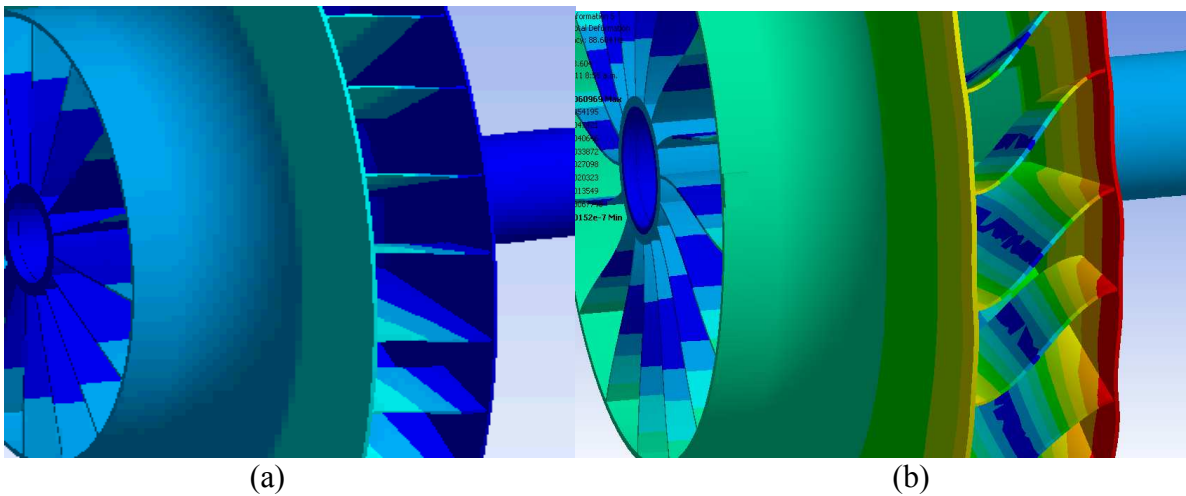
by rotating the impeller fronting and backplate in opposite directions (twisting), which in turn causes large strains at the blade welds as a result of the reversed bend displacement of the blades as shown in Figure 9(b).

(a) (b)
 Figure 9: Modal displacements of blades in torsion – from an FEA study
 (a) in first mode (b) in second mode

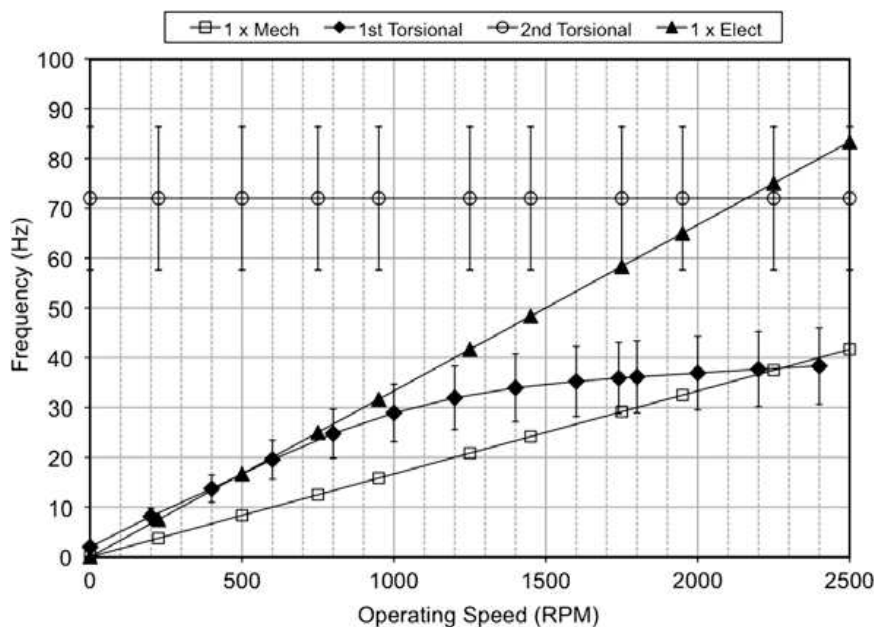
Figure 10: Interference diagram (Campbell)

- It can be seen that there is a close correspondence between the 1x Electric line (triangles) and the 1st torsional mode line (diamonds) from 0 rpm up to about 800 rpm, suggesting that this would

deliver pulses from the VSD at a frequency that virtually corresponds to the first torsion mode natural frequency. This will excite the 1st mode and potentially drive the system unstable.

- From 1750 rpm upwards, the 1st torsion modal frequency $\pm 20\%$ (indicating the region for design where natural frequencies should be avoided) overlaps with the 1x mechanical (i.e., shaft speed) and is at risk of being excited by the shaft rotation alone. This has nothing to do with the VSD controller, but is to do with a low coupling stiffness (a higher coupling stiffness would lift the first mode torsional line clear of the 1x mechanical line).

- The 1x Electric frequency line (triangles) overlaps with the 2nd torsional mode frequency line from about 1800 rpm onwards. This means that the VSD controller will deliver pulses at a frequency that correspond to, and excite the 2nd mode directly. The centre of this range is very close to 2150 rpm, the maximum running speed for the impeller.

- The VSD generates a side frequency (equal to 100 Hz minus the set point frequency) and this also can cause excitation of the torsion modes.

The solution to the problem of rapid fatigue failure was to use a V/Hz motor controller (open loop), rather than the SVC controller algorithm (with ‘virtual feedback’) that was in use. This avoided significant excitation from the controller and was adequate for the MVR process. Following a change to the V/Hz control, a waterfall plot of the fan shaft torque showed that there was little excitation of the second torsion mode– see Figure 11. However, the 1st mode torsion remained but pressure to return to production precluded a study to determine its severity.

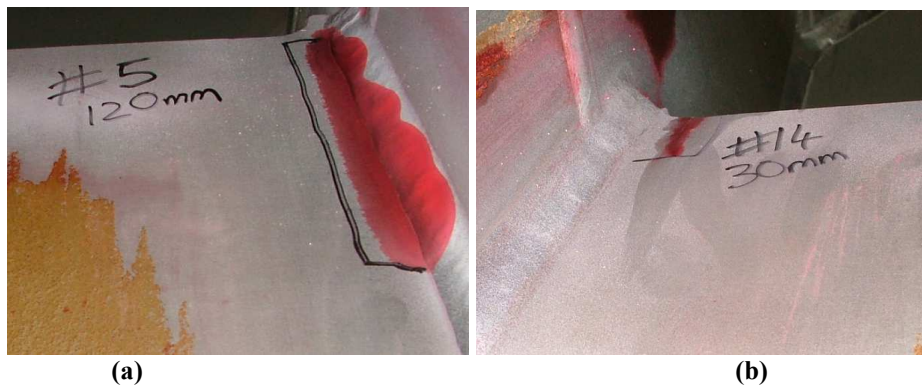
current investigation began. Dye penetrant now revealed extensive cracking but this time only on the pressure side of the blades (Figure 12). Only short blades were cracked and these exhibited an unusual pattern. The cracks appeared at the toe of welds on the front ring edge and were relatively long – around 120 mm. The cracks at the backplate edge of the blades were short – around 30 mm, in parent material and orientated along a blade diagonal – see Figure 13. One blade contained a crack that had propagated through the whole thickness (5 in Figure 13). Scanning electron microscopy (Figure 14) showed that failure was due to low cycle high load fatigue with perhaps 5 to 10 thousand cycles. As cracking had occurred during the previous 2 years of operation, the loading events required could be represented by single isolated events of severe loading, a random or isolated packet of cyclic loading, or repeated periodic low cycle events. Figure 13 shows there were more long cracks than short cracks and that they appeared to be distributed about a diametral line.

Figure 12: Dye penetrant on blades showing (a) long crack and (b) short crack types

Torsional vibration was eliminated as the cause in this second failure as the cracking was on some blades only and from one side of the blades only, where in the first case all blades were cracked and exhibited on both sides of the blades.

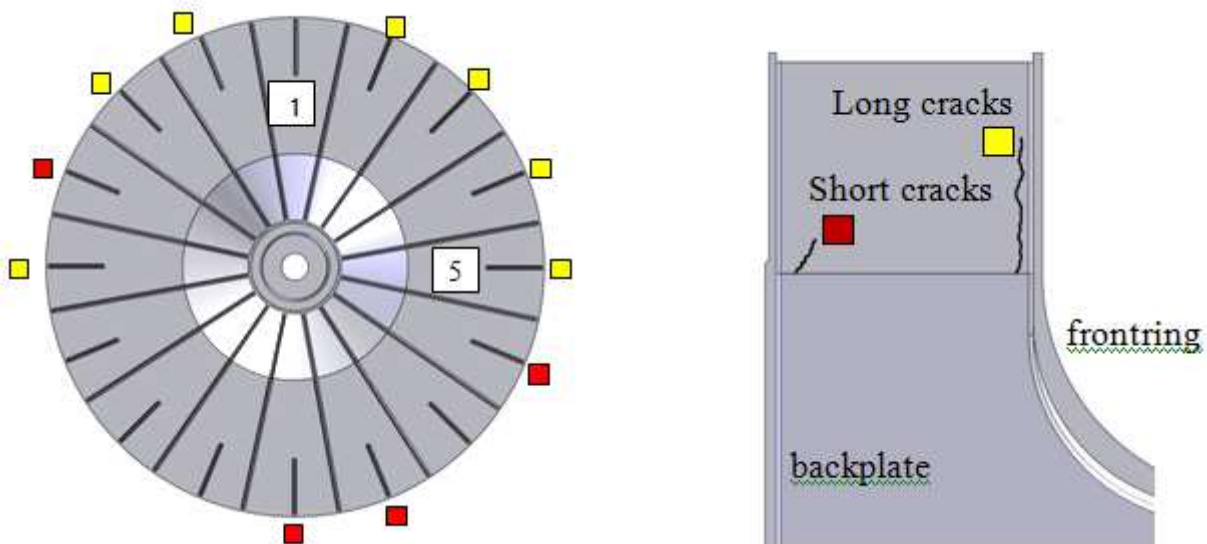
Figure 13: Sections through the impeller showing locations of the two types of crack
Note: only the short blades were cracked

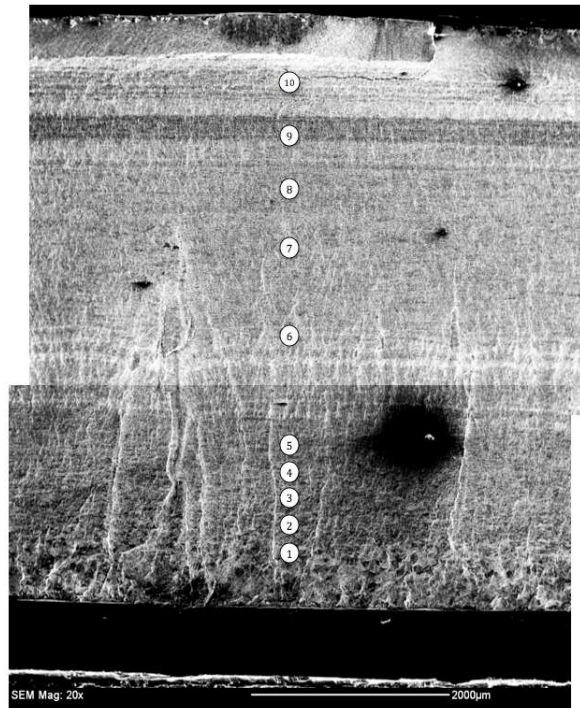
Figure 14: Montage of scanning electron images from the crack surface of a blade with a through crack. The numbered white circles indicate locations at which higher magnification images were taken for striation spacing measurements.

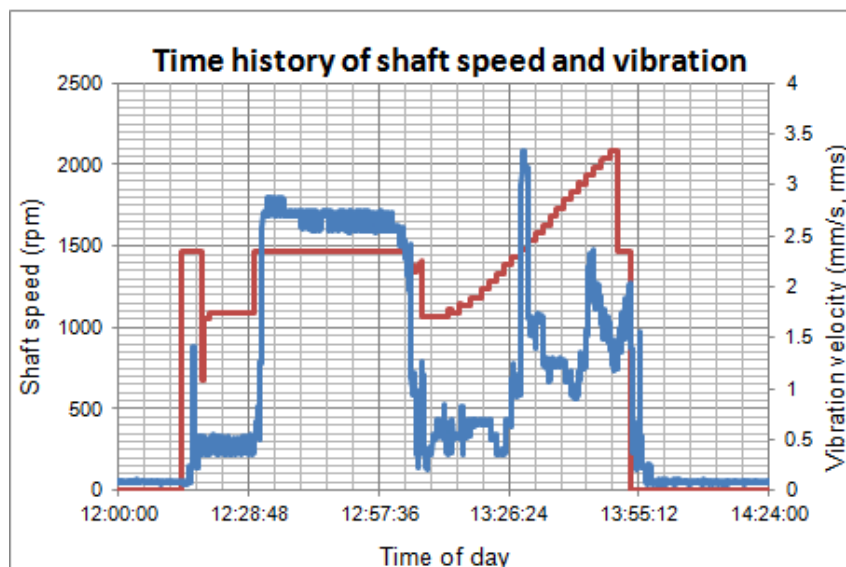
Figure 15: Plot for vibration response on run up speed tests shows resonance at 24.5Hz

There then appeared to be a high probability that the measured 24.5 Hz resonance was a transverse bend mode in the horizontal plane where the stiffness has its lowest value. It would appear that excitation comes from imbalance (and possibly gyroscopic torque) that is caused by the rotor sitting lower than the axis of rotation by some 250 to 300 microns because of clearance in the bearing. Thus the bend mode is synchronous with rotation – a critical speed. That is, the shaft exhibits a whirling motion where the orbit is flattened in the vertical plane due to the gravity load and horizontal motion is limited by the clearance in the bearing. Vibration occurs only when the fan is running at, or passing through, this critical speed of 24.5 Hz (1470 rpm). Unfortunately, at this time, there was no possible way to install proximity sensors to monitor shaft motion and the bearing housing cover will have to be modified to allow access for probes. Testing to determine shaft displacement and blade strains during processing are planned for the next annual maintenance shutdown.

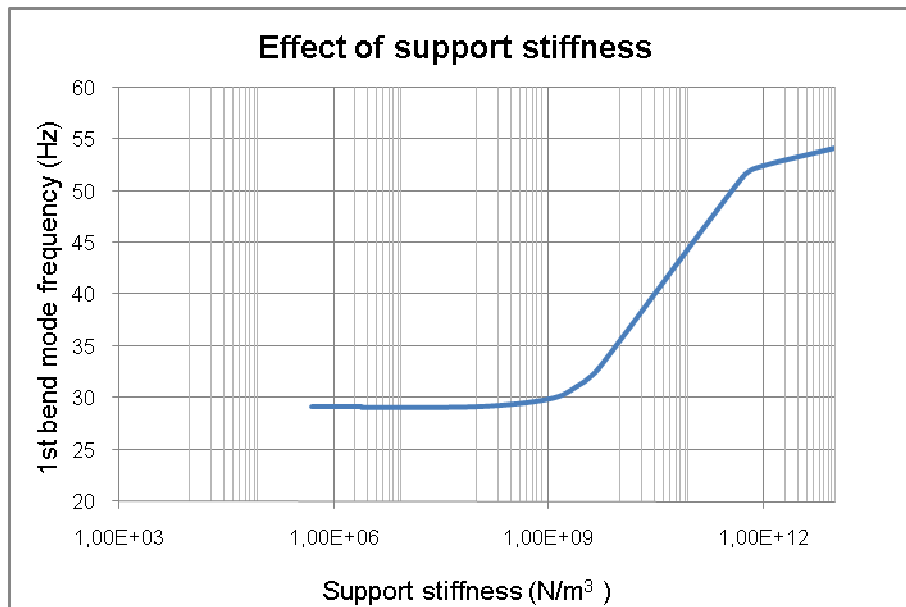
Figure 16: Plot of 1st bend mode frequency for the MVR rotating assembly

bearing with a diametral clearance of 200 microns. The gravity load keeps the shaft in contact with the rollers at the lowest point of the bearing; this provides a higher stiffness in the vertical plane than in the horizontal plane. It was suspected that the dynamic stiffness of the bearing would be lower than its static stiffness during the impact tests, so a series of analyses was carried out using FEA software to study the effect of varying the bearing support stiffness. This showed that the predicted bend mode can occur over a wide frequency range according to bearing stiffness – Figure 16.

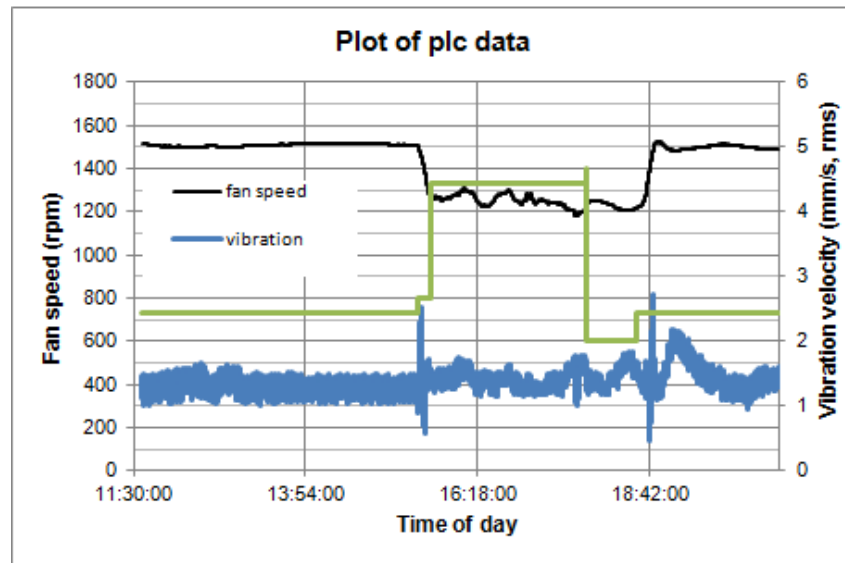
Observation of the plant's PLC (programmable logic controller) screen records showed a daily event where the critical speed is passed through twice each day. The event occurs for CIP (clean in place) when the fan slows down, is cleaned and then runs up to normal operating speed. Figure 17 shows a typical PLC screen for the MVR fan, where the black trace shows the fan shaft speed, the blue trace shows the vibration level, and the process step number (that shows CIP has been called) is shown by the green trace.

Figure 17: plc screen display showing correlation between vibration events and fan speed

The current hypothesis for the mechanism of failure is that the shaft undergoes a sharp whirl for perhaps three cycles as it passes through the critical speed on either ramp up or ramp down. The whirl is limited by the clearance in the roller bearing where the impeller deflection is limited by the restoring force in the shaft. One CIP event per day would equate to around 4000 cycles over two years operation, which is consistent with the forensic metallographic observations.

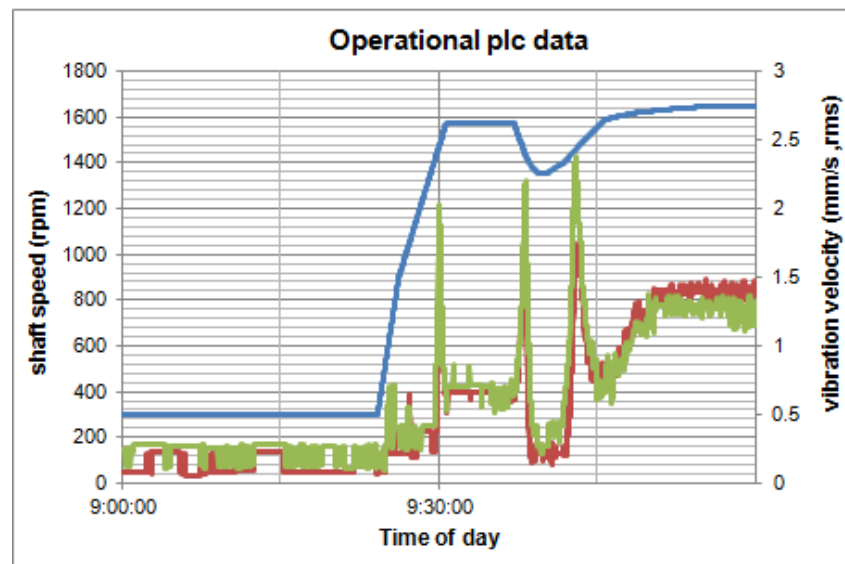
Figure 18: plc data for newly commissioned MVR fan

Tests at a more recently commissioned new factory showed the same correlation between vibration level and speed change – see Figure 18. The blue trace shows the fan speed where the green and red traces are the vibration levels taken at the in-board and out-board fan bearings respectively. Note that whilst the vibration levels appear to be low, the sensor monitors motion of the bearing housing (and pedestal) and not the motion of the impeller. It is possible for the impeller to have a much greater peak level of vibration that is not ‘seen’ by the relatively slow scanning speed of the plc logger.
