ENDLESS FIBRE REINFORCED COMPOSITE- METAL-IMPELLER: HIGH SPEED BURST TESTING - DAMAGE AND FAILURE ANALYSIS

SUMMARY

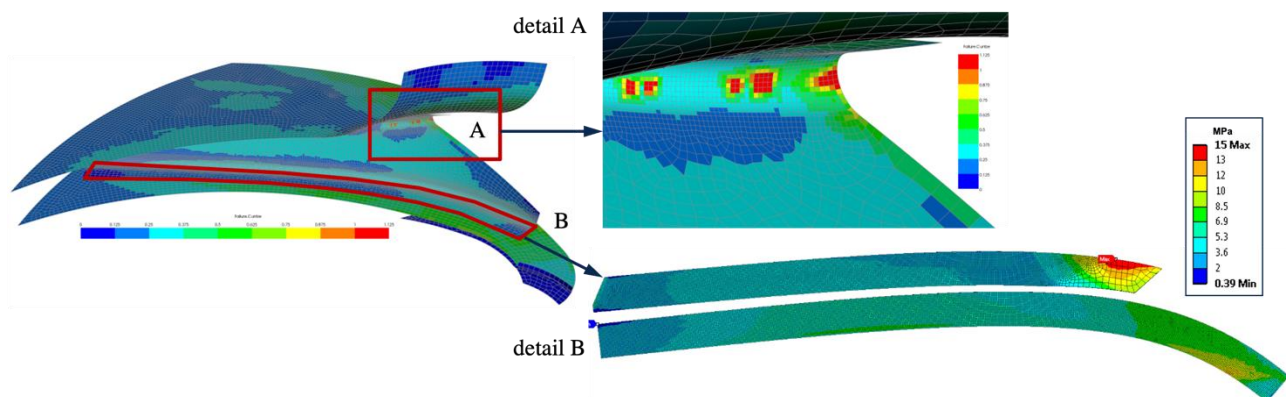
For the modular design of the impeller, two aspects are assessed: the structural effort with regards to the CUNTZE failure modes and the stress distribution in the interface in-between the blades and the disks. Figure 5 shows the CUNTZE-effort of an impeller segment (left) with the detail A of the critical area in the radius of the blade (right top) and the stress distribution in the bonding interface (left, right bottom). If damaged or failure accrue, it is expected to be at the radius of the Z-shaped blades or in the joining interface between the discs and blades.

Figure 5: CUNTZE-effort of an impeller segment (left) with the detail A of the critical area in the radius of the blade (right top) and the detail B of the stress distribution in the bonding interface (left, right bottom)

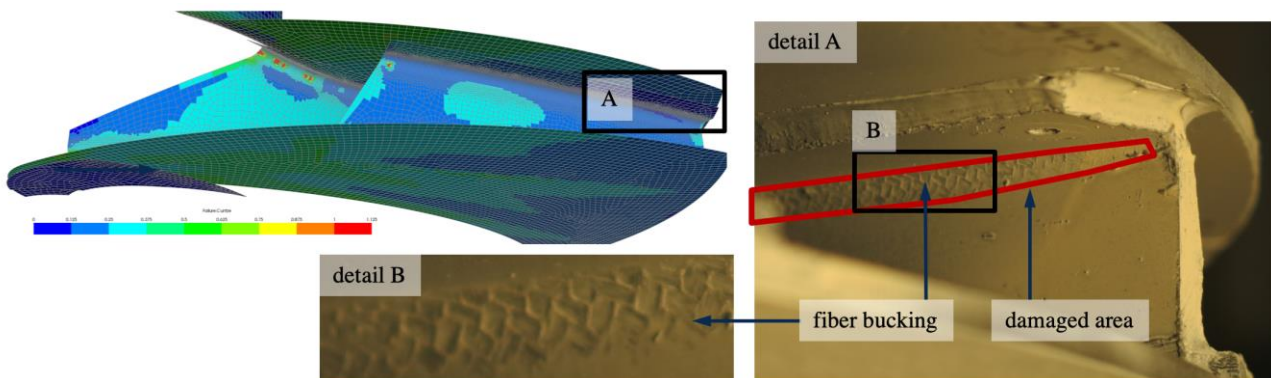
During the spin test, the impeller is inspected after defined load steps, to identify initial damage and failure of the material. Figure 7 shows the numerical model of a segment (left - top) with the area of initial damage of the impeller (detail A, right) and initial failure of the material (detail B, left). However, this initial damage does not lead to any impairment of the general functioning of the component. The initial damage occurs differently from the numerically predicted place. At the predicted point of initial failure there is no structural change or initial damage visible.

Figure 7: numerical model of a segment (left - top) with the area of initial damaged of the impeller (detail A, right) and initial failure of the material (detail B, left)

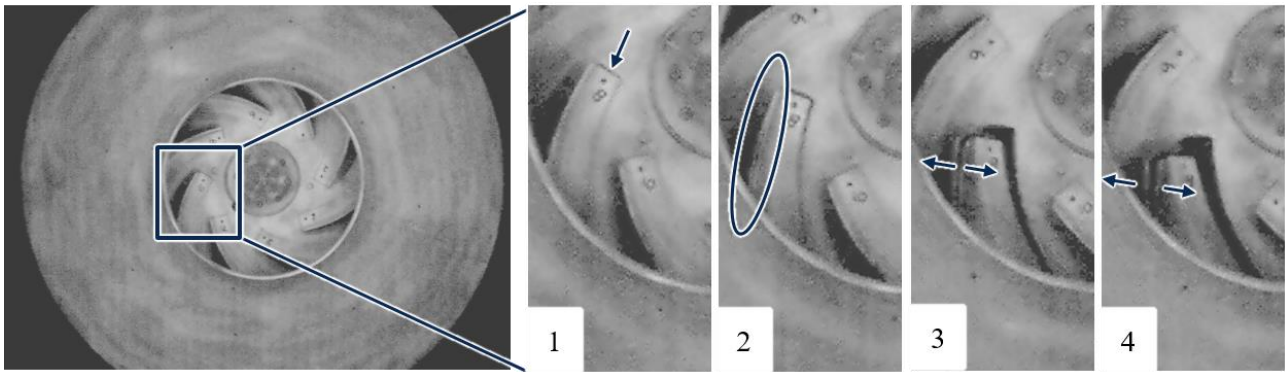
Figure 8 on the left shows the impeller during rotation. The footage shows that blade no. 08 is the first to detach from the disc. In the process, the blade itself delaminates (red line in pictures 1-4) and thus loses its load-bearing effect. After this initial failure, other blades shear off and the cover disk wobbles and fails by hitting the containment.

Figure 8: images from the high speed recordings of the impeller failure with the presumed initial failure at blade no. 08

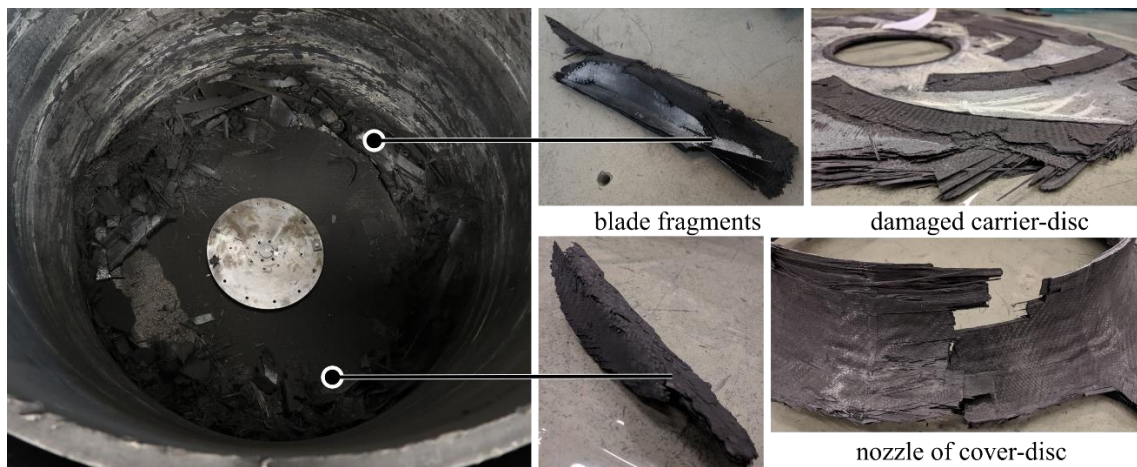
The modular impellers fail mainly in the joining areas, resulting in fragments in the form of the individual components or characteristic elements (acc. Figure 9).

Next to the individual blades, the discs can be clearly seen, with the flat carrier disc as a disc. The cover disc has disintegrated into smaller fragments. The nozzle is recognizable as a closed ring. All individual parts show strong delamination, especially near the impact areas.

Figure 9: burst impeller (left) and fragments of the bursted impeller (right)

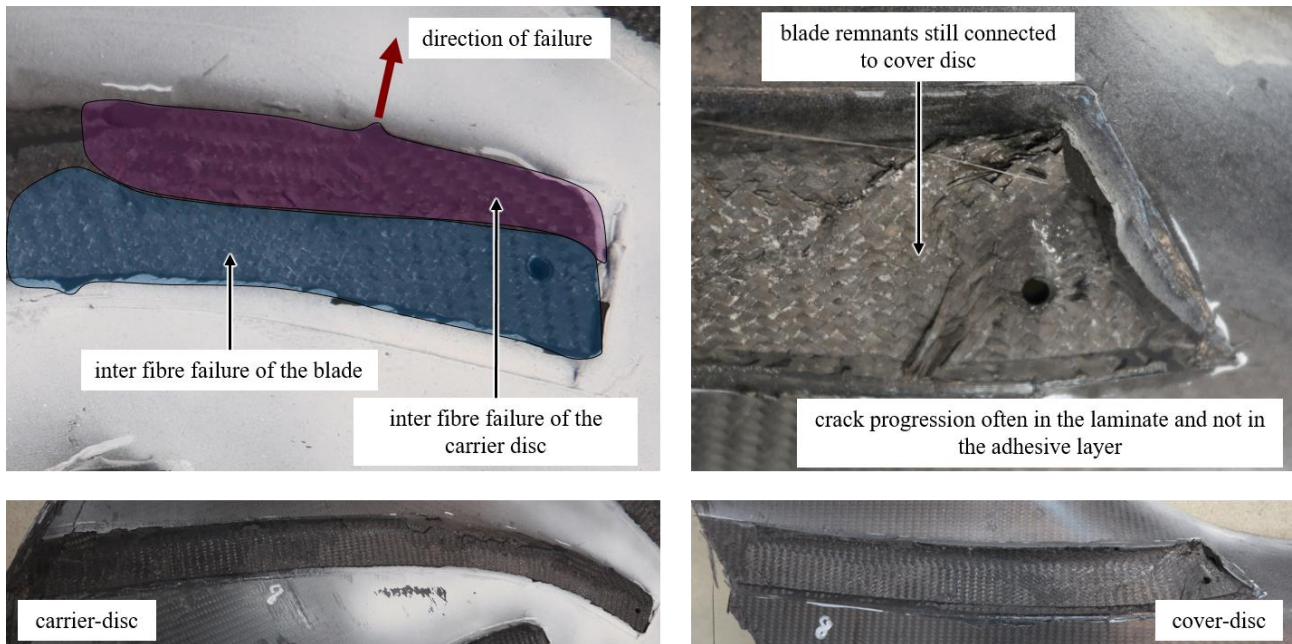
Remarkable are the fracture surfaces between the blades and discs (acc. Figure 9, right top). It can be seen from the fragments that interlaminar failure has occurred in the joint area between the blade and the discs, with the fracture shape alternating between failure in the laminate of the blade and failure in the adhesive layer (acc. Figure 10, left top). Minimally noticeable fragments of the discs can also be found on the vanes (acc. Figure 10, right top). This fracture pattern is characteristic of a mixed fracture and indicates that the interlaminar strengths of the fibre composite and the strength

of the adhesive are at similar levels, which under the given test conditions (dry and ambient temperature) can be interpreted as a suitable choice of material.

Figure 10: fracture surfaces of the fragments with interlaminar failure in the components of the blade, the disks and the adhesive

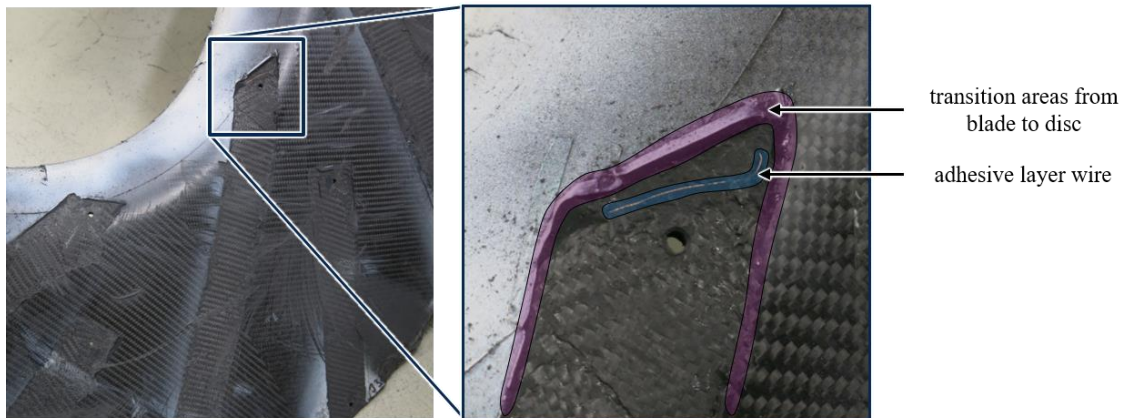
In the fragments of impeller 1, the cause of the initial failure can be deduced (acc. Figure 11, left). The copper wire inserted to adjust the slit is located in the fracture surface. The wire in combination with the still relatively undefined geometry of the transition areas from blade to disc and the comparatively low manufacturing quality may be the cause of the lowest circumferential speed of 310 m/s (acc. Figure 11, right).

Figure 11: fragments of impeller 1 with the potential crack initiator in the form of the inserted adhesive layer wire

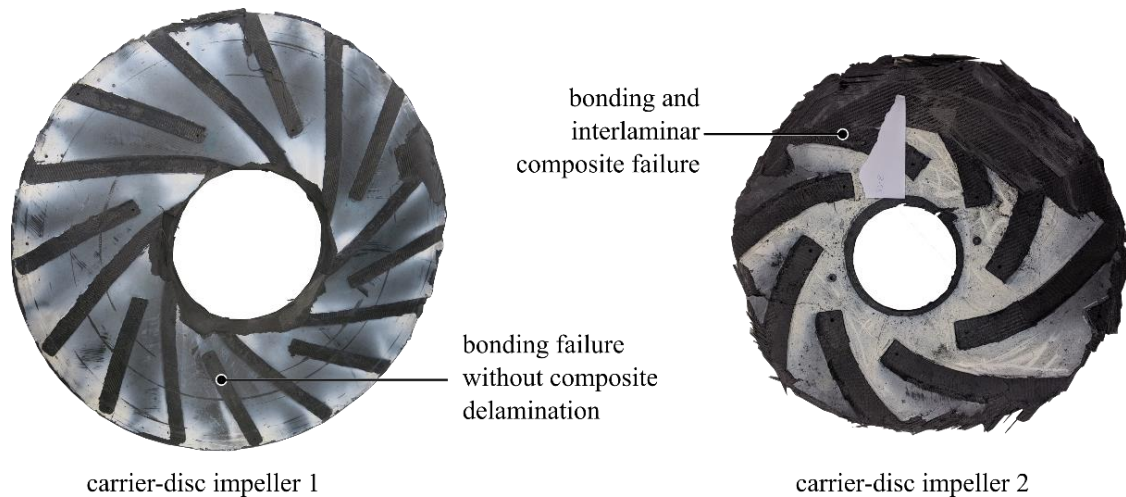
Due to the relatively low circumferential speed (310 m/s) of impeller 1 (acc. Figure 12, left) at the time of failure and the almost exclusive failure of the bonding interfaces, the carrier disc remains largely intact. The carrier disc of the impeller 2 (acc. Figure 12, right), on the other hand, is more severely damaged due to greater centrifugal forces caused by an increased circumferential speed (538 m/s) at the time of failure. In addition, fibre composite delaminations contribute to damage of the structure due to the increased joint strength.

Figure 12: fragment of the carrier-disc of impeller 1 (left) and impeller 2 (right)
