FAILURE ANALYSIS OF IMPELLER BLADE CRACKING IN A MECHANICAL VAPOUR RECOMPRESSOR (MVR) FAN

Brian DONOHUE, Milo KRAL

Department of Mechanical Engineering, University of Canterbury, New Zealand

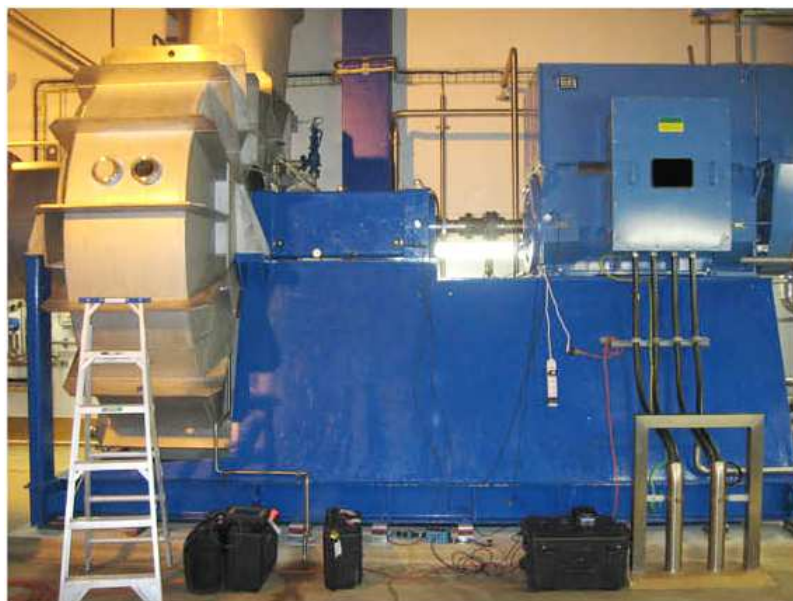
Figure 2: The MVR fan

The impeller was entirely fabricated from duplex stainless steel plates by TIG and MIG welding – a normal requirement for sanitary applications such as dairy. The overall impeller diameter is approximately 2 metres with an inlet diameter of approximately 750 mm and hub height of approximately 500 mm. The front ring of the impeller varies in thickness from 10mm to 25mm in 2205 duplex, the backplate is fabricated from 8mm and 12mm duplex, and the blades from 6mm LDX 2101 duplex. There are 32 blades in total, one set that are full length and span from the inlet ring to the discharge, and a shorter set that are spaced intermediate to the long blades. The weld filler material was 2205. The impeller was dynamically balanced in the factory prior to dispatch and field balanced in-situ during commissioning. In the first failure event where a blade was thrown (mass around 3kg), a considerable unbalance was generated sufficient to shake the whole building. The impeller was rotating at 1950rpm at the time the failure occurred.

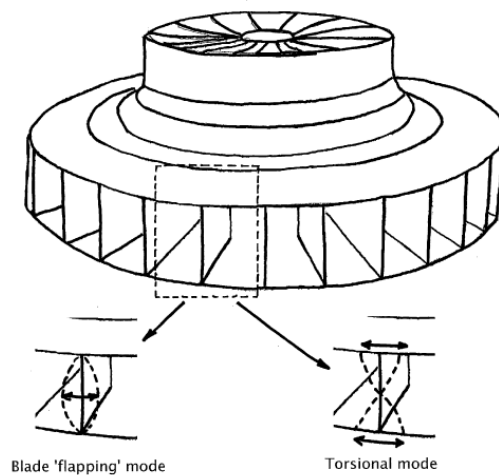
Figure 5: Two possible modes of blade vibration

At this point in the analysis, it was only clear that fatigue was the fracture mechanism and that there was a lack of fusion in the thrown blade. However, other fan blades were cracked as well. One possible explanation for the impeller failure was that the blade with a defective weld had fatigued due to resonance then severe vibrations occurred due to imbalance after the blade was thrown, which in turn resulted in other cracks being formed. So, a root cause analysis [2] was carried out since a source of stress to drive fatigue crack growth in the thrown blade had not been immediately identified. In seeking a source of stress, two vibration modes were conceptually identified: a blade ‘flapping’ mode and a torsional mode - see Figure 5.

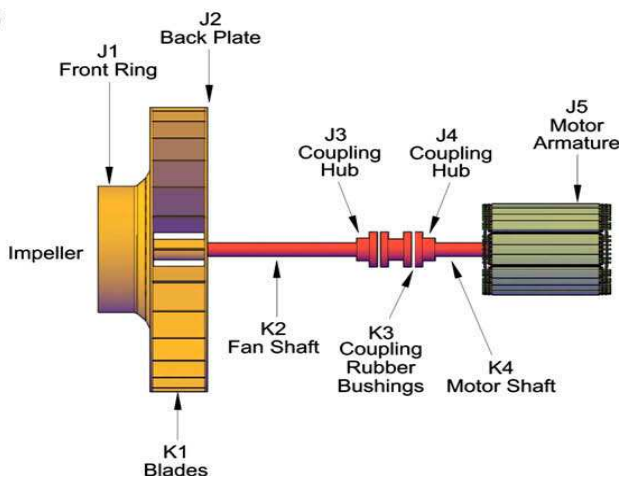
Figure 6: Model for torsional analysis

Simplified models were then developed using measurements taken from the failed impeller, see Figures 6 and 7, in order to gain a better insight into the resonant motion.

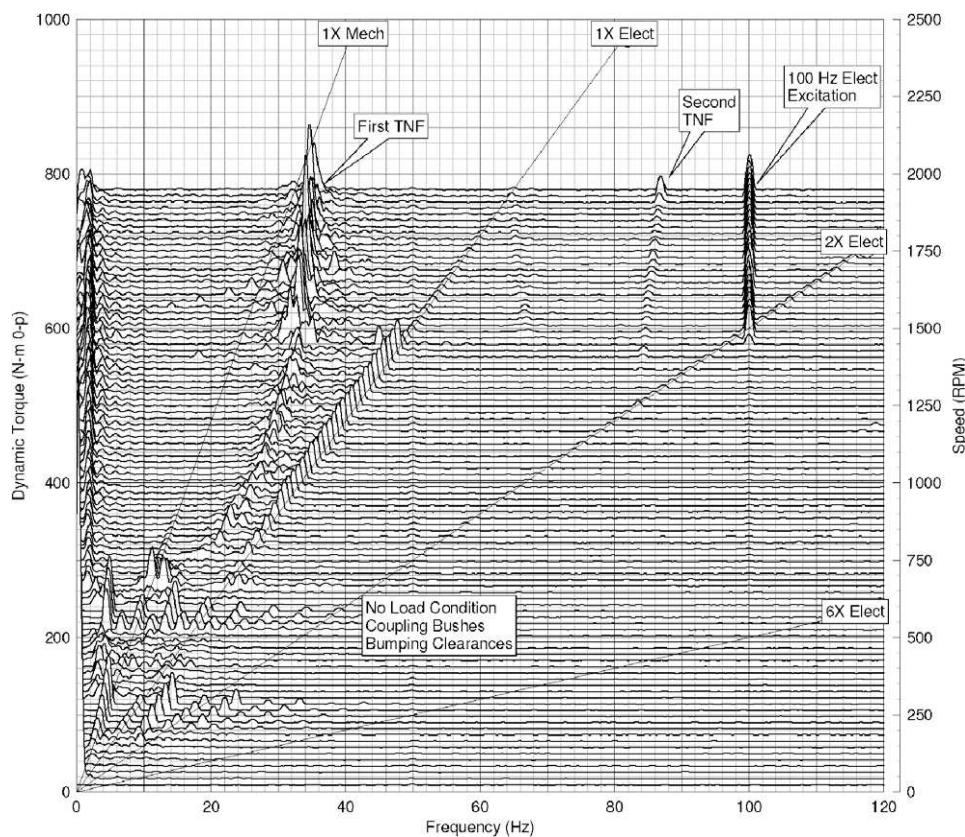
Figure 11: Waterfall plot taken from torque measurement data during a shut down [1]

- The VSD generates a side frequency (equal to 100 Hz minus the set point frequency) and this also can cause excitation of the torsion modes.

The solution to the problem of rapid fatigue failure was to use a V/Hz motor controller (open loop), rather than the SVC controller algorithm (with ‘virtual feedback’) that was in use. This avoided significant excitation from the controller and was adequate for the MVR process. Following a change to the V/Hz control, a waterfall plot of the fan shaft torque showed that there was little excitation of the second torsion mode– see Figure 11. However, the 1st mode torsion remained but pressure to return to production precluded a study to determine its severity.
