ENDLESS FIBRE REINFORCED COMPOSITE- METAL-IMPELLER: HIGH SPEED BURST TESTING - DAMAGE AND FAILURE ANALYSIS

SUMMARY

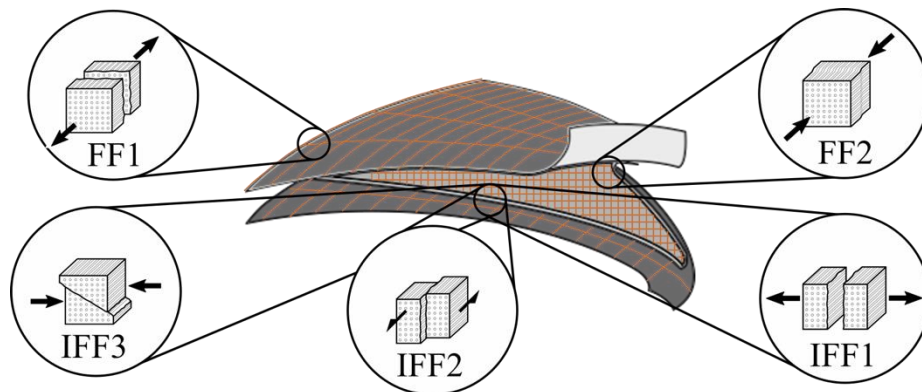
Figure 4: probable material failure modes according to CUNTZE [7] in relation to the structure of the modular impeller

Orthotropic FRP material systems can be interpreted using failure mode related methods e.g. PUCK and CUNTZE to predict the mechanical capability on a micro scale level during mechanical loading [7, 8]. CUNTZE describes two fibre failure modes (FF1, FF2) and three inter fibre failure modes (IFF1, IFF2, IFF3). In an impeller with the proposed design and material orientations (acc. Figure 1), these material-related fracture modes can be assigned to different areas of the structure (acc. Figure 4).
